REPORT OF GEOLOGIC OBSERVATION OF CELL No. 13 CONSTRUCTION

**EAST CAROLINA REGIONAL MSW LANDFILL
BERTIE COUNTY, NORTH CAROLINA
SOLID WASTE PERMIT NUMBER 08-03**

BLE Project Number J12-1001-71

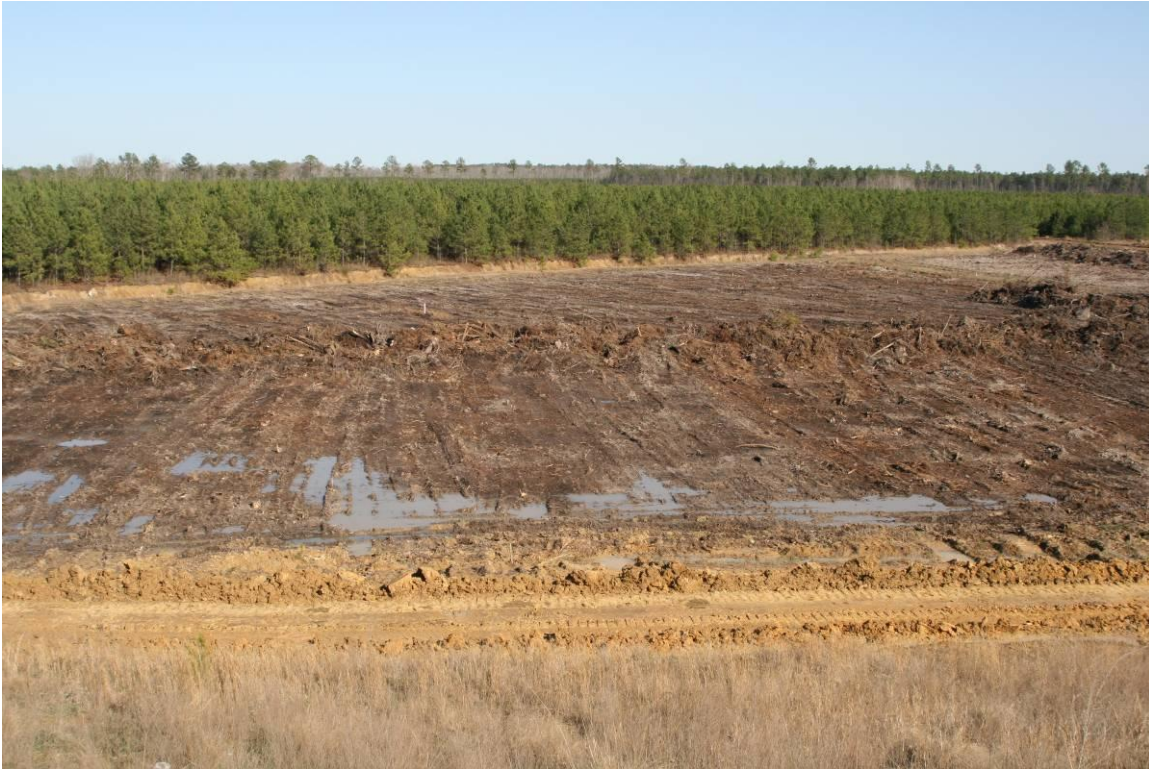
The “A horizon” soils were removed from the Cell No. 13 ground surface during March to August 2009 (Photographs 1-4).

Photograph 1: (March 2009) Cell No. 13 subgrade following clearing and prior to topsoil removal and placement of compacted fill. Photograph taken facing east.

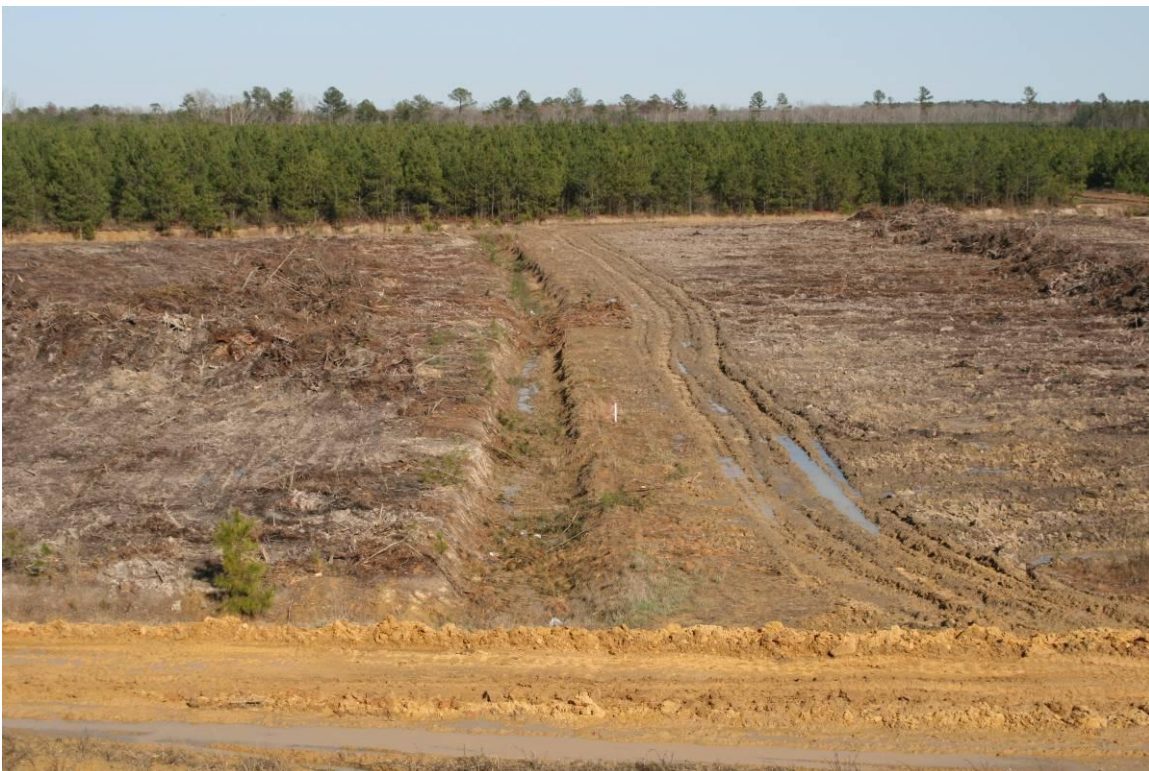
Photograph 2: (March 2009) Cell No. 13 subgrade following clearing and prior to topsoil removal and placement of compacted fill. Photograph taken facing east.

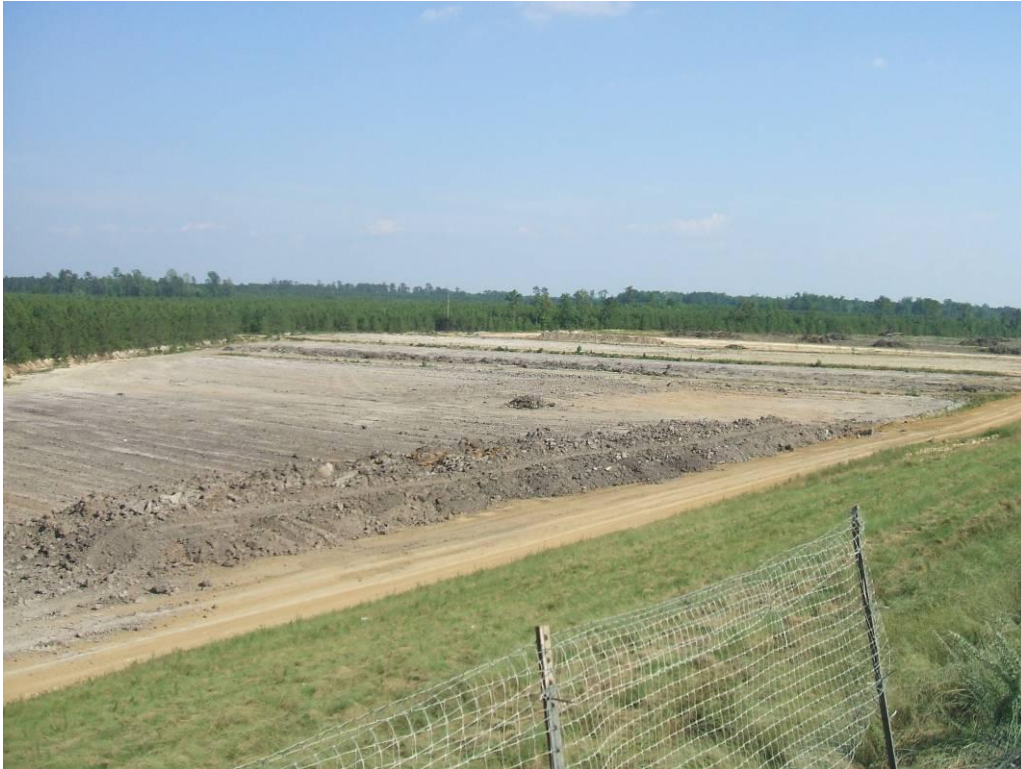
Photograph 3: (June 2009) Subgrade after the removal of the topsoil.
Photograph taken facing southeast.

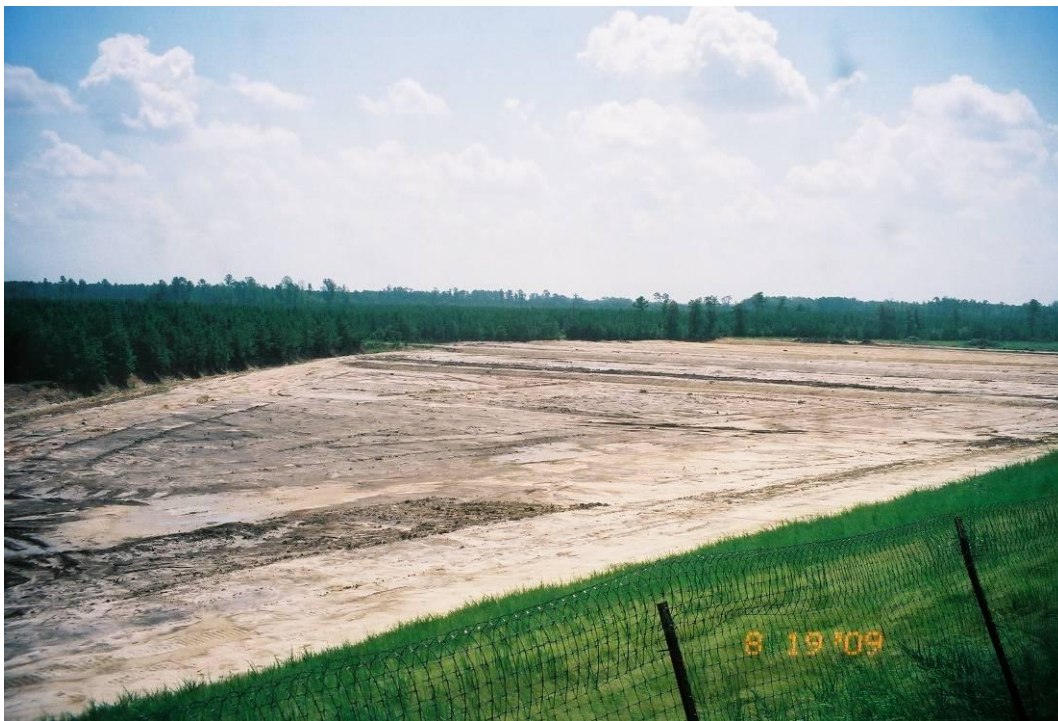
Photograph 4: (August 2009) Subgrade after the removal of the topsoil.
Photograph taken facing southeast.

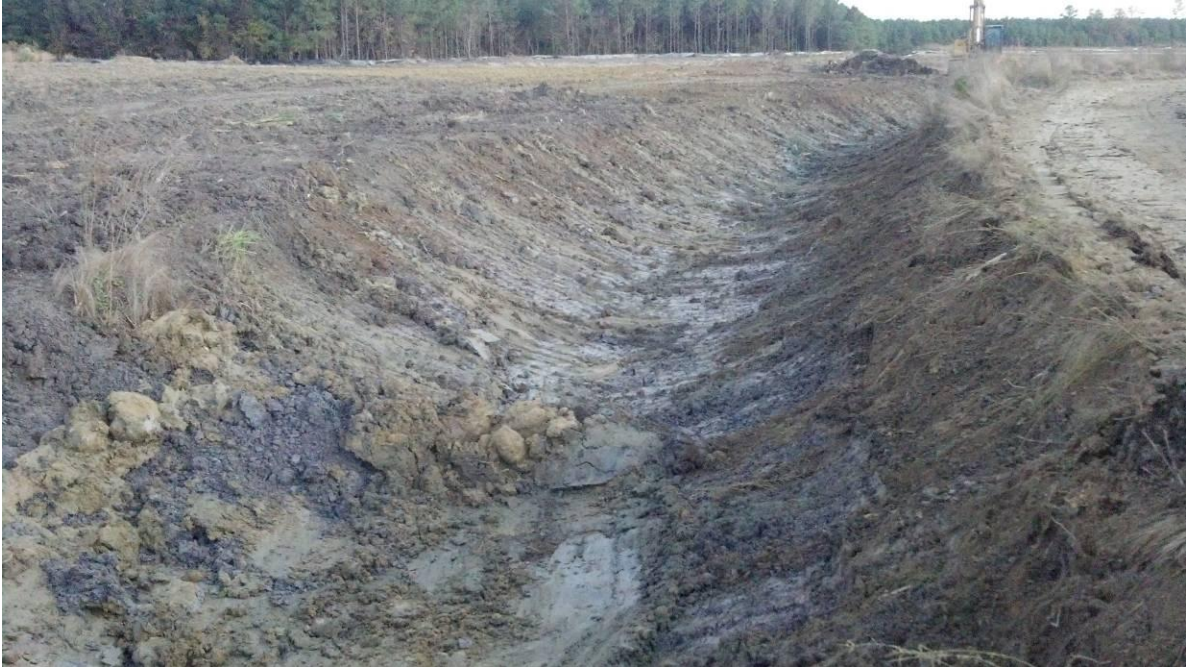
There were five drainage ditches in the footprint of Cell No. 13 and its fill embankment (**Figure 3**). Runoff sediments and plant material were removed from the ditches during June of 2009, June 2010, and November 2012 (Photograph 5). The removal of the runoff sediments was performed with minimal disturbance to Layer I using a bulldozer and a trackhoe excavator. In addition, two test pits were made to explore the Layer I soils in 2010.

Photograph 5: (November 2012) Removal of loose sediments and organic matter from a drainage ditch.
Photograph taken facing southeast.

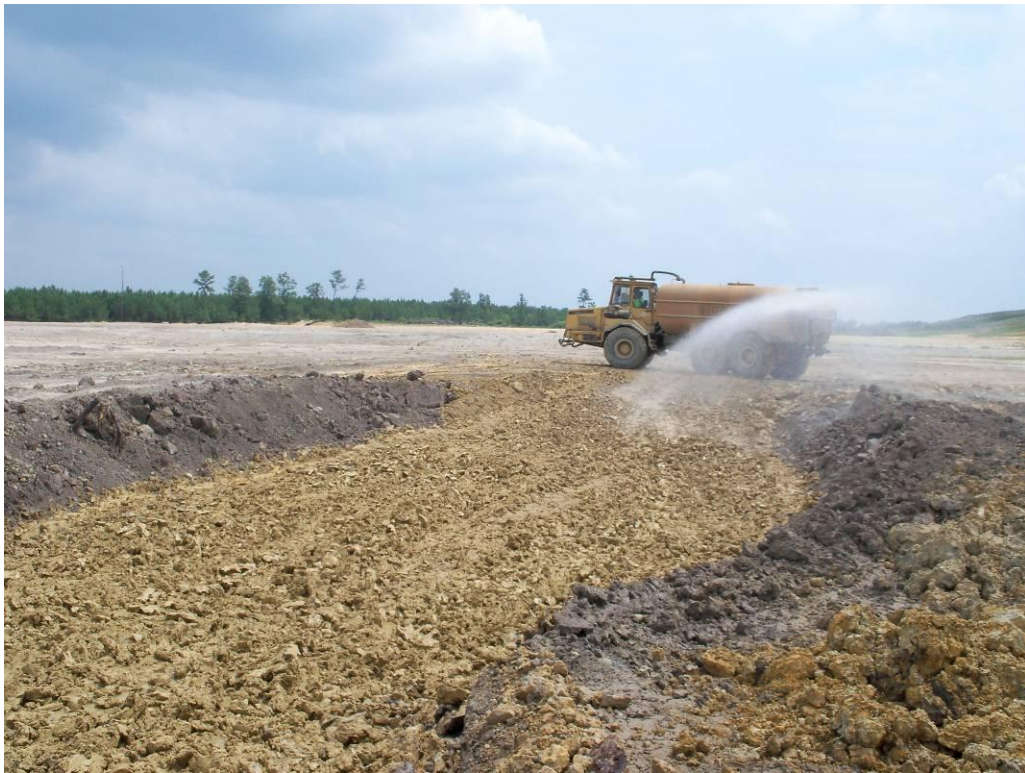
In accordance with the construction plans for Cell No. 13 (HHNT, June 2012), the surface water drainage ditches were backfilled with compacted clay liner soil with a permeability (K) $\leq 1.0 \times 10^{-7}$ cm/sec (Photographs 6 and 7) in 2010 and 2012. Confirmation CQA in-place density testing and undisturbed soil samples were collected at the site and tested in the laboratory during the placement of the fill soils. Twenty-two permeability test samples were obtained from varying representative depths and locations within the backfill of the drainage ditches. The permeability test results ranged from 1.0×10^{-7} to 1.6×10^{-8} cm/sec. The results of the confirmation samples will be included with BLE’s CQA report for Cell 13 and they demonstrate that the drainage ditch backfill soils achieved the specified density and permeability of $K \leq 1.0 \times 10^{-7}$ cm/sec.

Photograph 6: (June 2010) Filling and compacting of clay soils along a former drainage ditch location.
Photograph taken facing south.

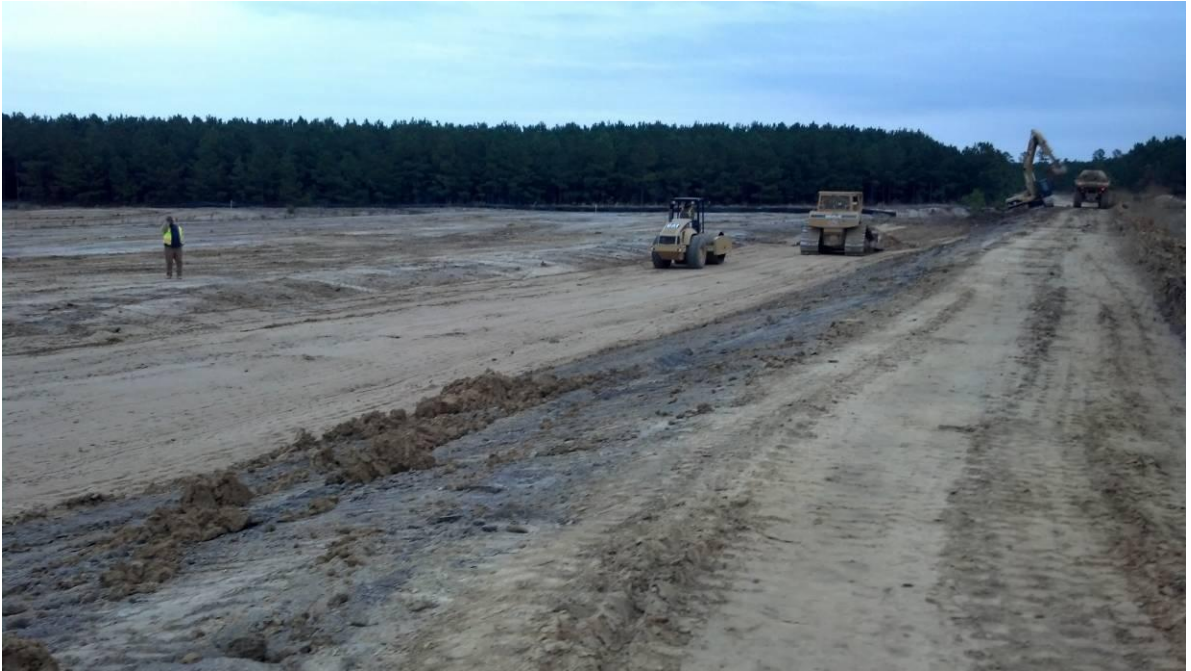
Photograph 7: (November 2012) Filling and compacting of clay soils along a former drainage ditch location. Photograph taken facing east.

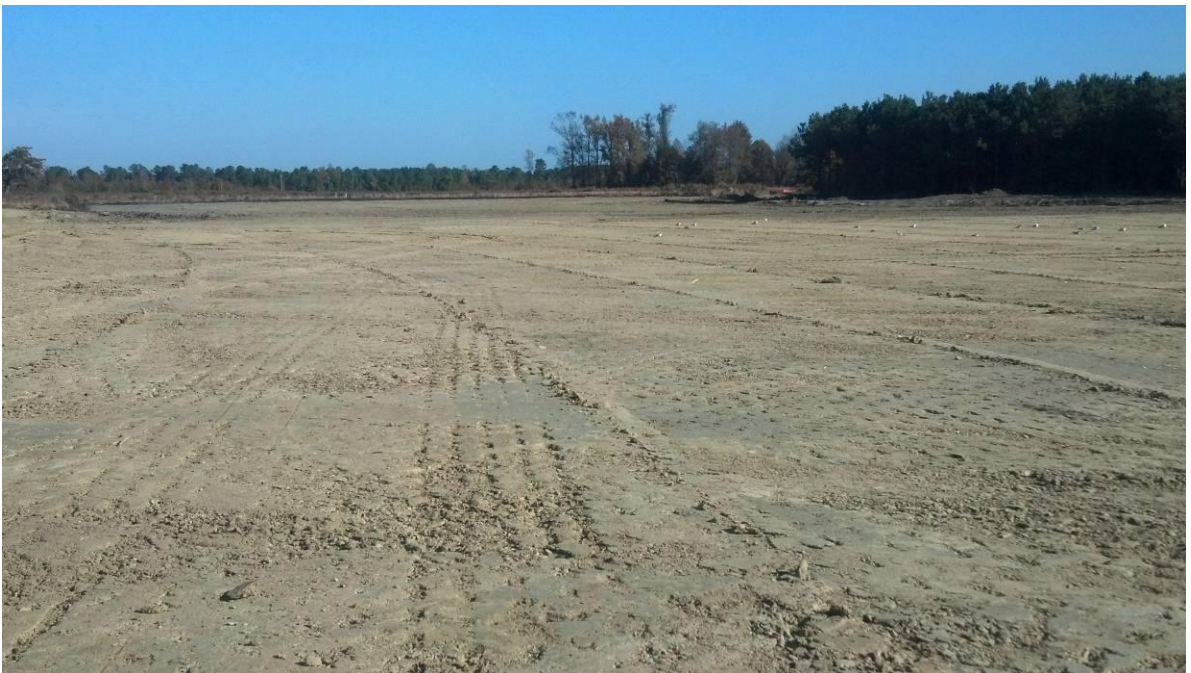
After removal of the topsoil, filling of the storm water ditches with compacted clay soils, and compaction of the former ground surface (Photograph 8), structural fill soil placement onto the subgrade began in November 2012.

Photograph 8: (November 2012) Subgrade prior to structural fill soil placement. Photograph taken facing north.
